# Revision Guide for AMD Opteron™ Processors

Publication # <b>25759</b>	Revision: <b>3.03</b>
Issue Date: <b>May 2003</b>

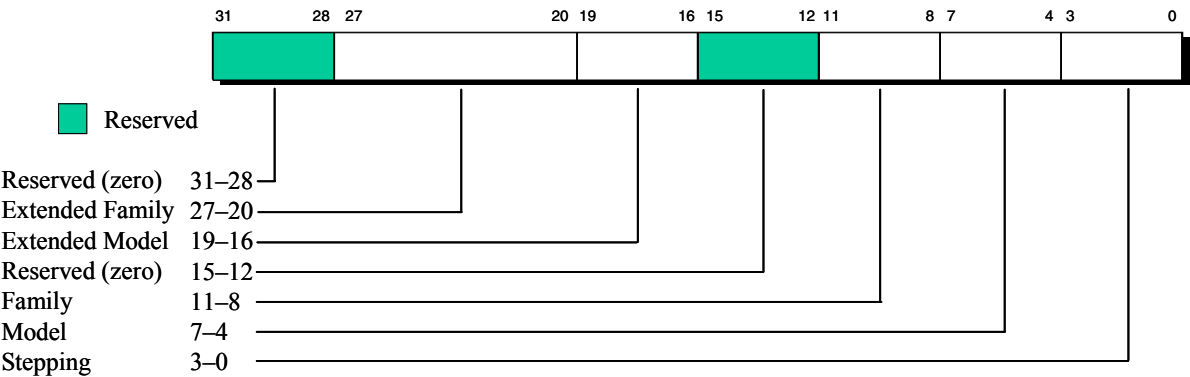
**Figure 1. Format of CPUID Value Returned by Function 1**

Figure 1 shows the format of the value returned in EAX by CPUID Function 1.
